## R109/24: Various models - Audio Sound pauses after I-STOP Operation

**TSB NUMBER: R109/24 (Europe)**

**Applicable Model:** Various models with Bose® type audio

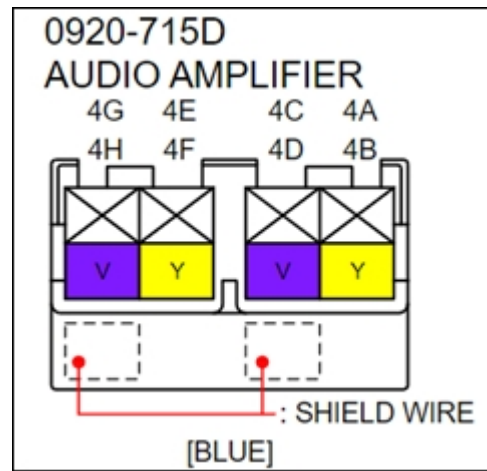
CX-5

3. Start monitoring while the ignition switch is on.
4. Disconnect the "MOST IN/OUT" connector from the audio amplifier referring to the workshop manual "AUDIO AMPLIFIER REMOVAL/INSTALLATION" and the wiring diagram "AUDIO SYSTEM (Bose® TYPE AUDIO)".

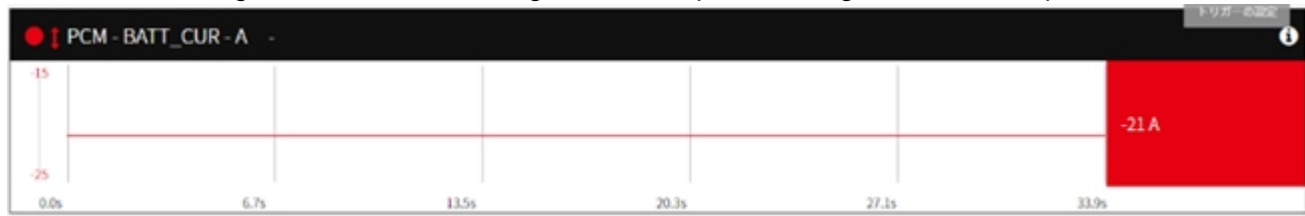
Fig. 1

[5-1] If the current is stable as Fig. 1.

Claim labor hours for the diagnosis and continue diagnosis and repair referring to the workshop manual.

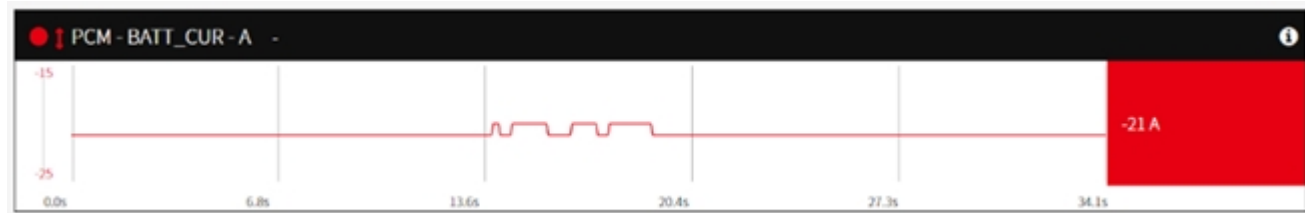
Fig. 2

**Due to an improper part in the audio amplifier installed in the factory, voltage drop error detection of the power source may be too sensitive.**

[5-2] If the current fluctuates multiple times about 1 A as Fig. 2, the audio amplifier has the concern. Replace the audio amplifier with a new one according to the workshop manual "AUDIO AMPLIFIER REMOVAL/INSTALLATION".
